Investigation and repair of 541 Cylinder Head failure

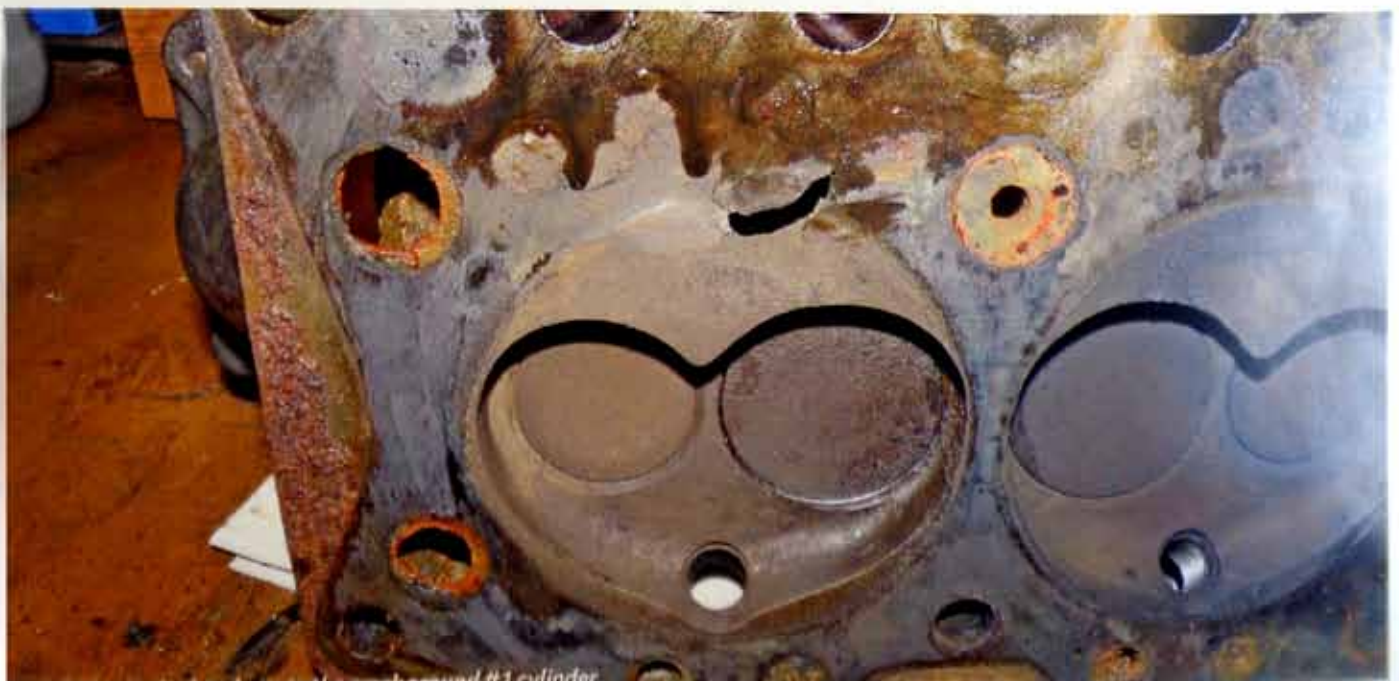
Initial inspection and description of symptoms indicated a major coolant leak into one or more of the cylinders. A compression test determined that cylinder 1 had no compression, 2 to 6 were all ok at around 120psi. There was a small trace of emulsification under the rocker cover indicating some contamination of the engine oil by coolant. The oil level appeared to be correct although it was suspected that some of the fluid in the sump was likely to be coolant. After removal of all the ancillaries around the upper part of the engine, the cylinder head was able to be removed for visual inspection. This clearly showed that the cylinder head had failed allowing coolant to enter cylinder 1.

Following the discovery of significant damage to the head, the three / four options open to us were discussed and it was decided that a new Denis Welch Motorsport "fast road" aluminium cylinder head would be ordered. This has a delivery time of about 8 weeks.

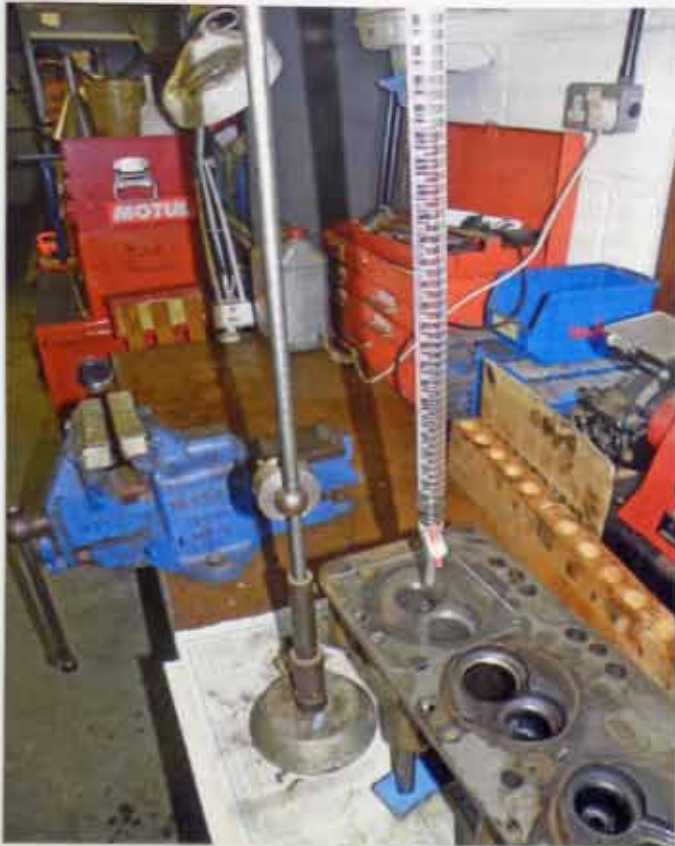
Measuring the volume of the kidney-shaped combustion chambers.....

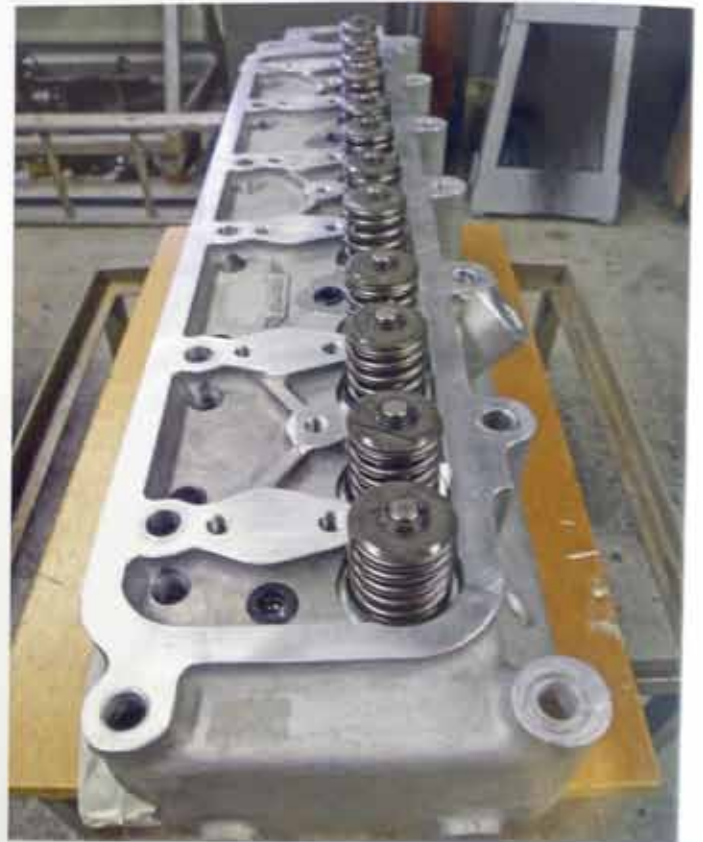
The new cylinder head fitted with pre-installed valves and double valve springs

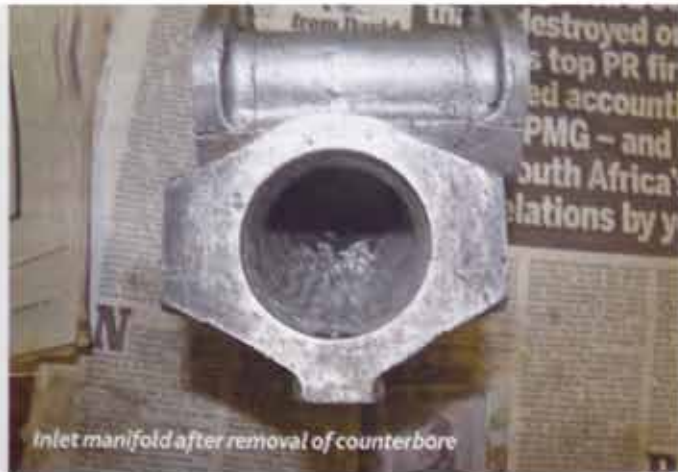
Inlet manifold after removal of counterbore

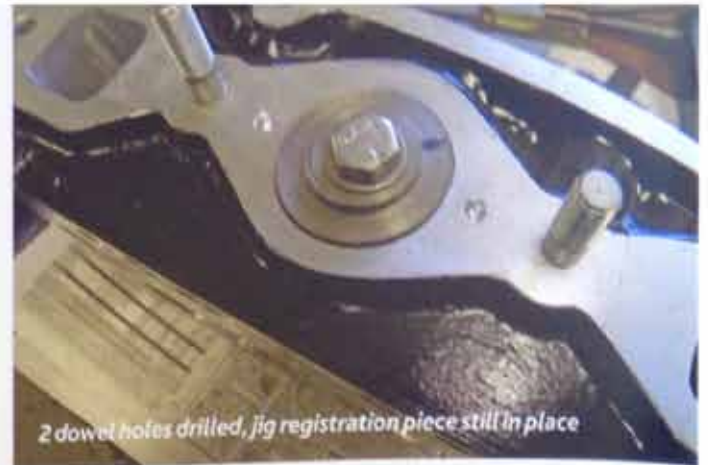
2 dowel holes drilled, jig registration piece still in place

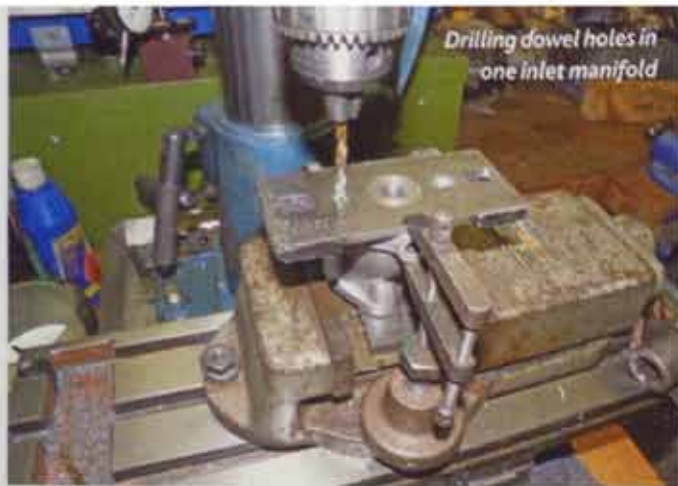
Drilling dowel holes in one inlet manifold

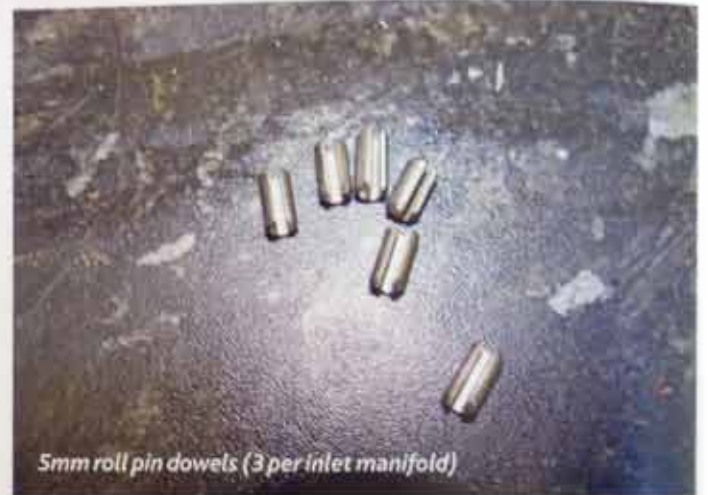
5mm roll pin dowels (3 per inlet manifold)

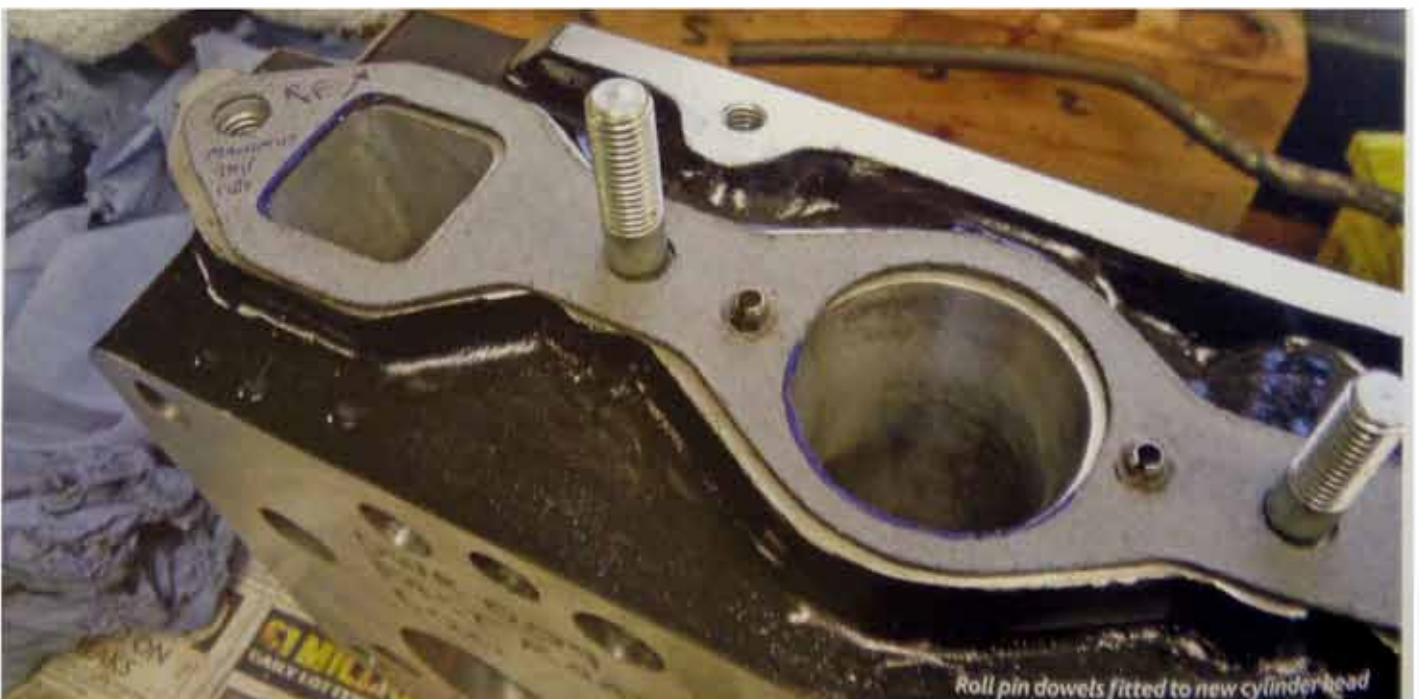
Roll pin dowels fitted to new cylinder head

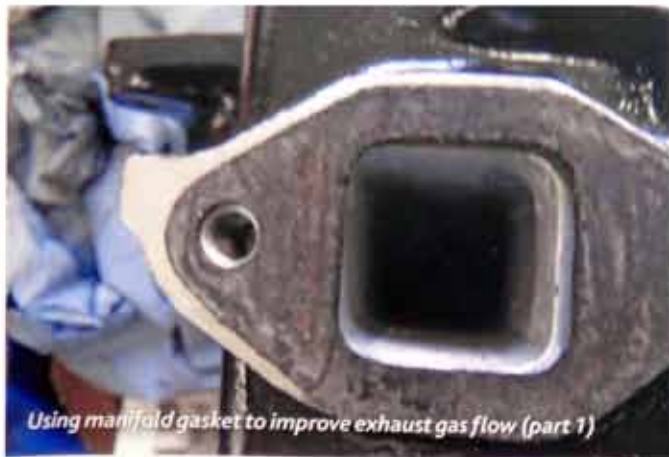
Using manifold gasket to improve exhaust gas flow (part 1)

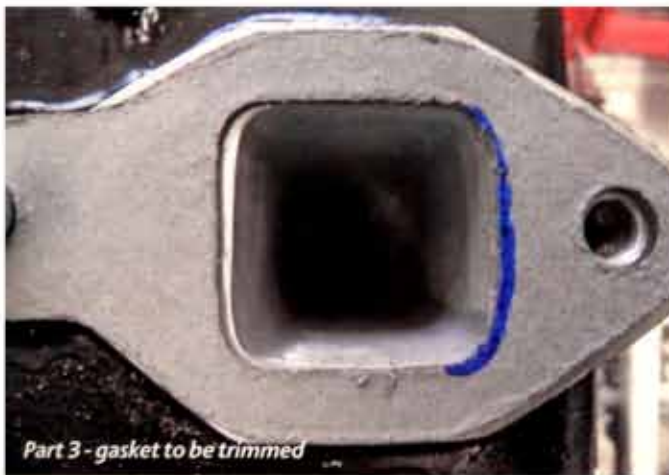
Part 3 - gasket to be trimmed

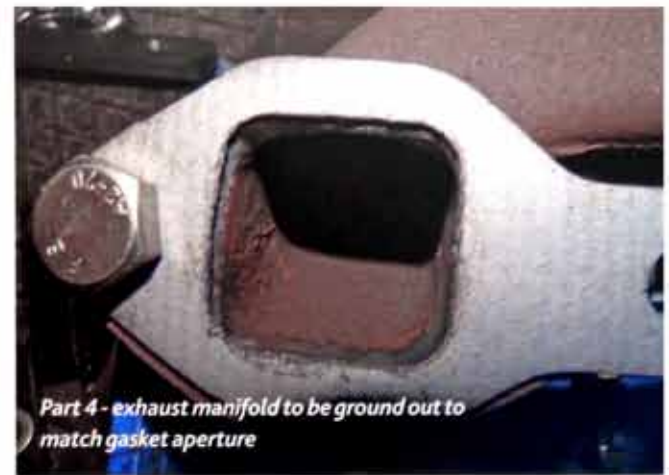
Part 4 - exhaust manifold to be ground out to match gasket aperture

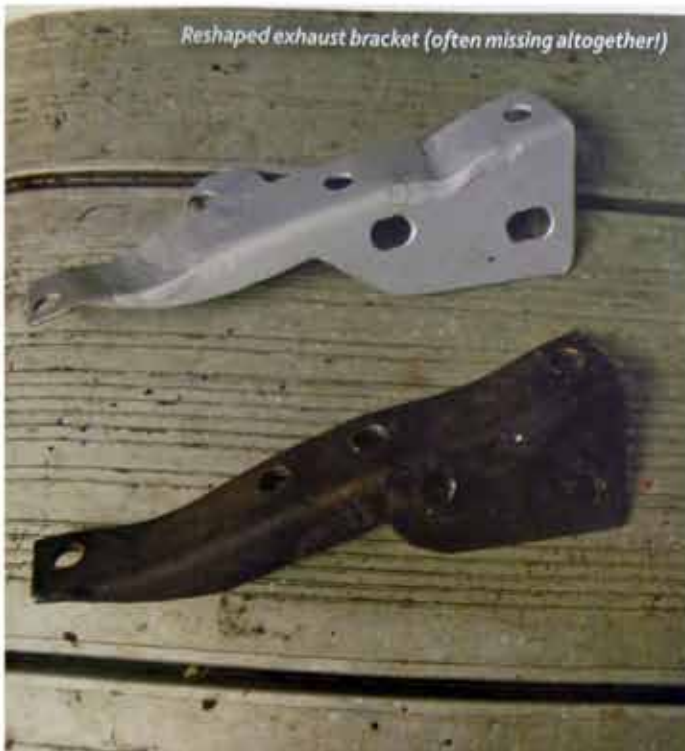
Reshaped exhaust bracket (often missing altogether!)

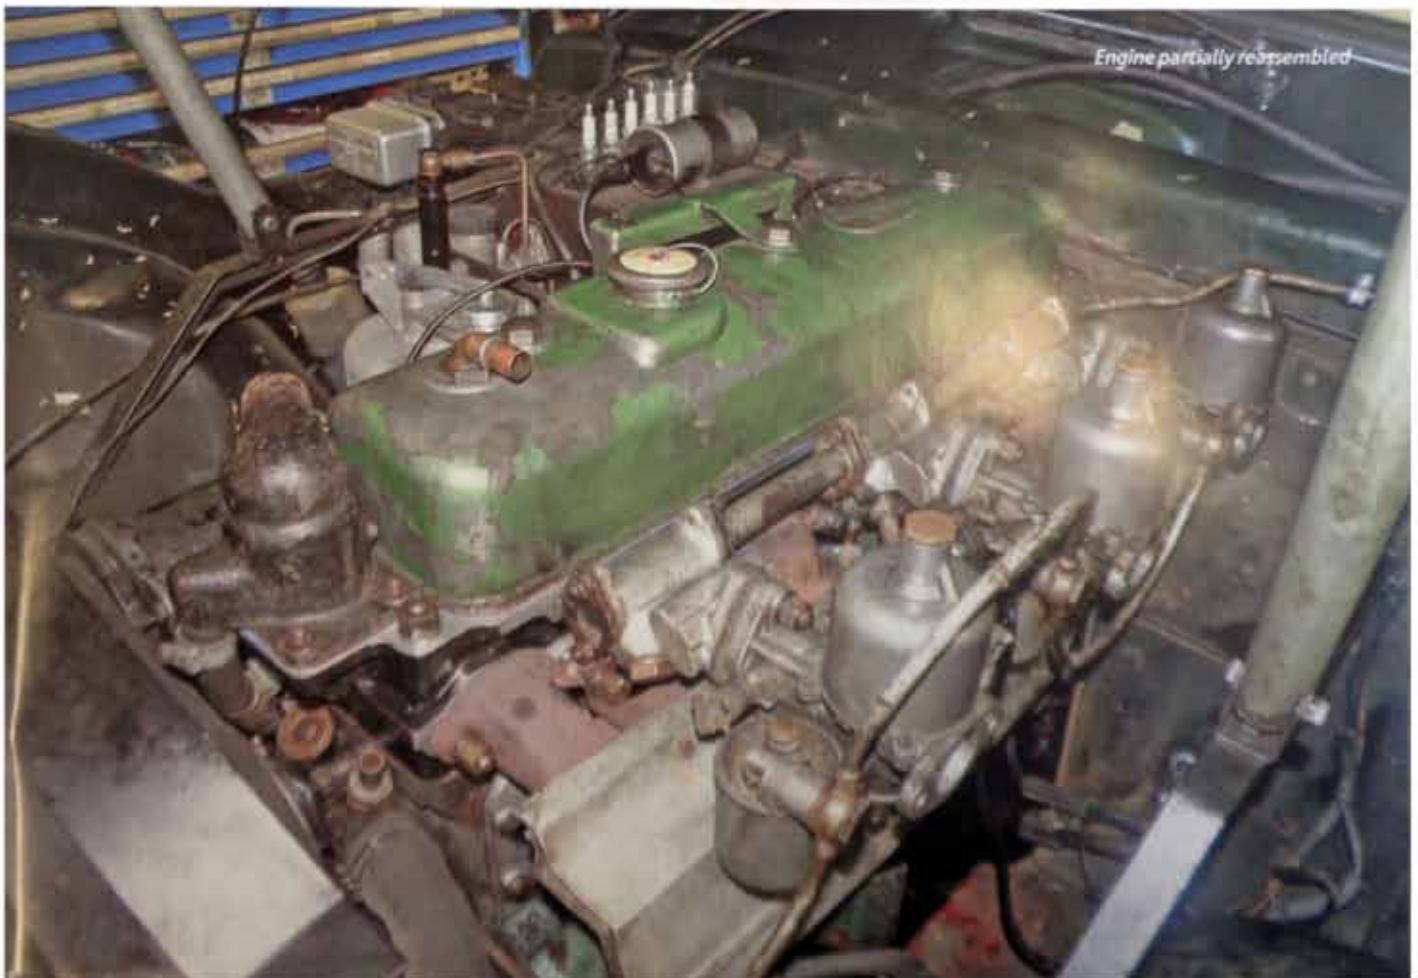
Engine partially reassembled

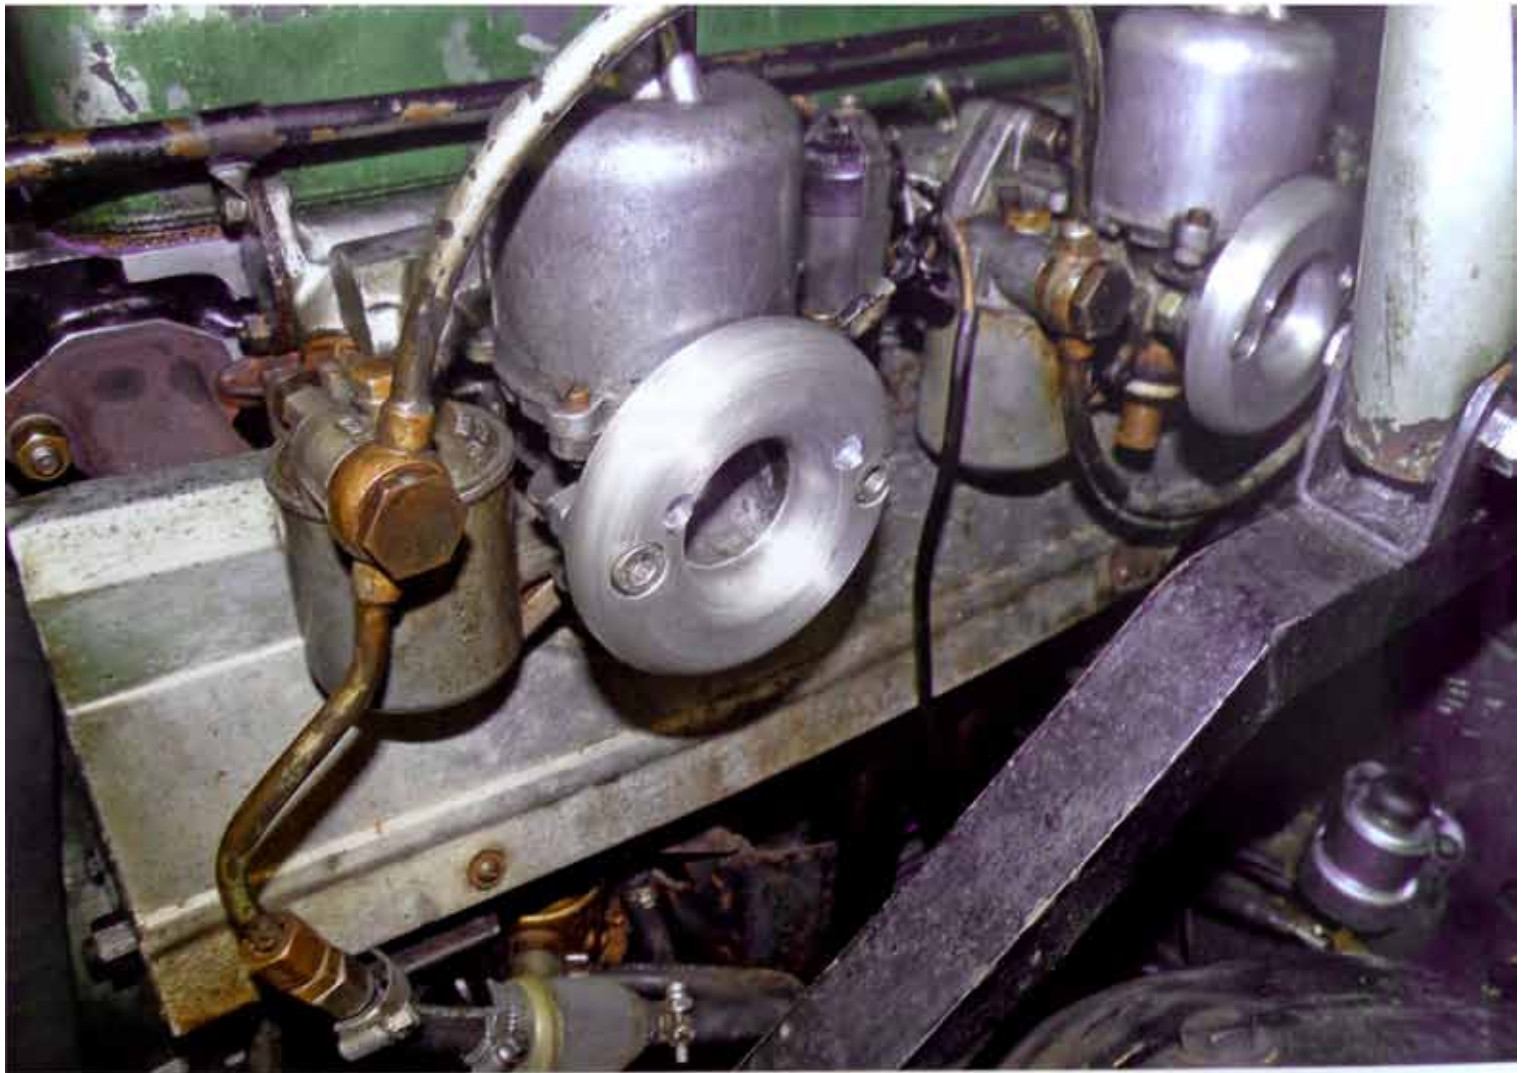
Stub Stacks fitted for carb tuning and balancing (eventually these are hidden within the original 541 air box and fit within the standard Burgess air filters)
