Investigation and repair of 541 Cylinder Head failure

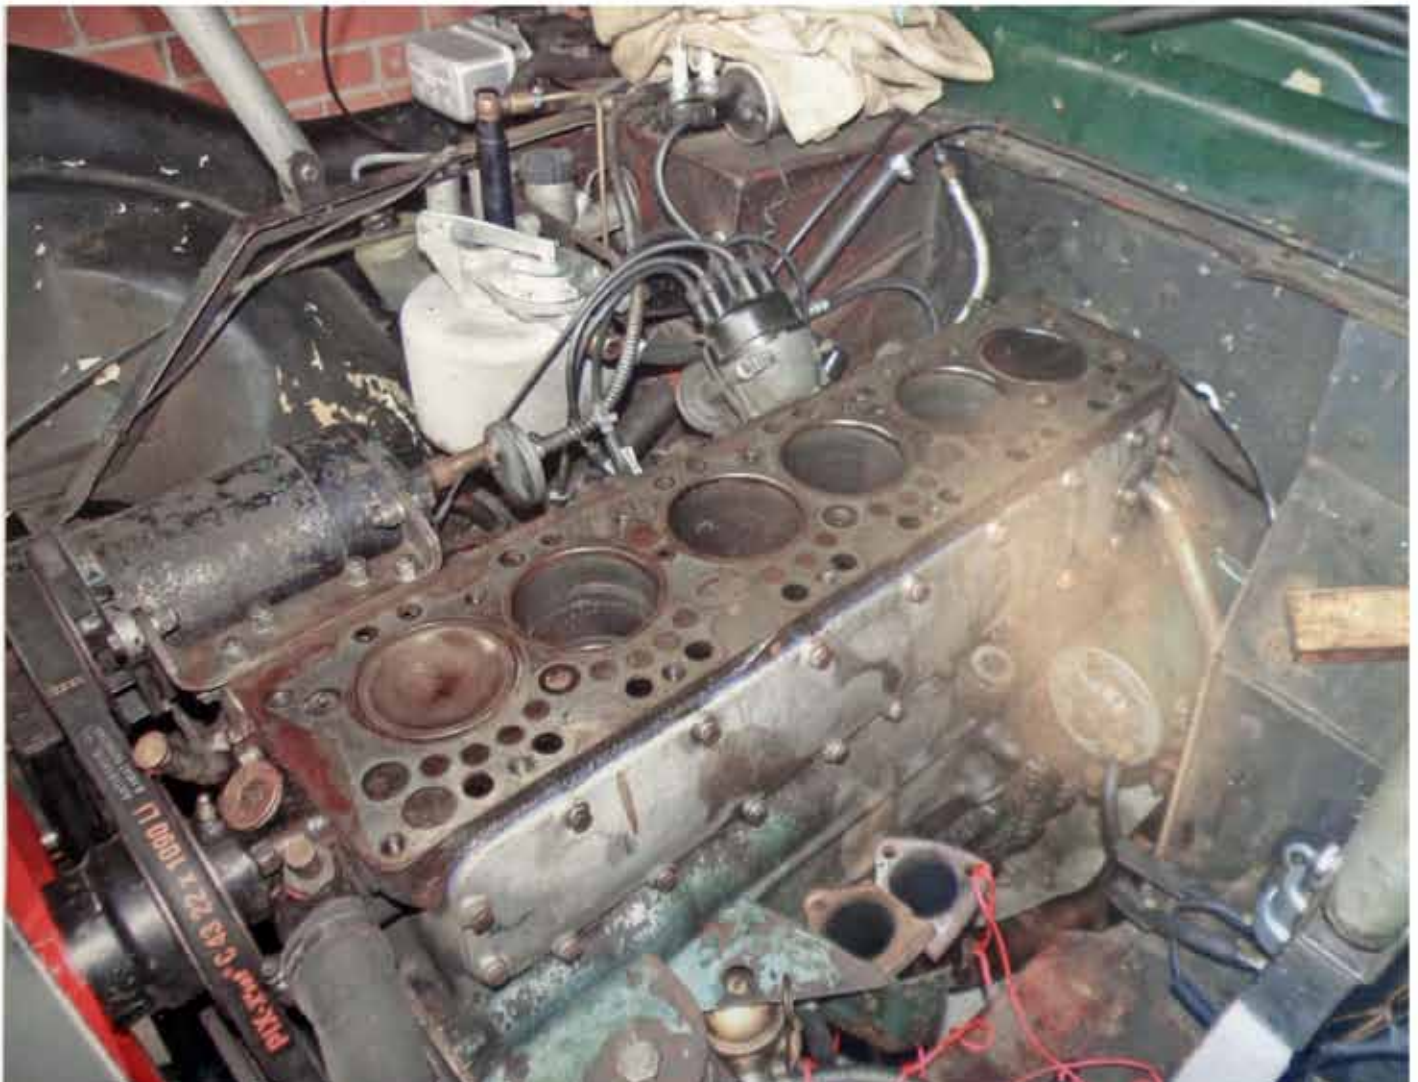
To determine the desired compression ratio and thereby the combustion chamber volume in the new cylinder head, various measurements were taken (all converted to metric to ease calculations later):-

- Stroke: 111.3 to 111.5mm
- Piston to deck height: between 0.0 and 0.13mm
- Used gasket thickness (relaxed state): 1.50mm (1.35mm assumed for gasket when compressed)
- Piston dish depth: 14.3mm
- Piston dish diameter: 77.5mm
- Old head combustion volume: 58.6 to 64.1 cubic centimetres (cc) (variation due to measurement difficulties, meniscus
- repeatability, original manufacturing tolerances and possible small variations in valve recession). 61.5cc was assumed as the nominal value.

The above measurements were fed into an Excel spreadsheet (which was developed from first principles) to confirm a nominal compression ratio of around 7.4:1 which verified that the old cylinder head had been skimmed by circa 3/32 inch (2.38mm). Without this skimming, the compression ratio would have been around 6.8:1 – the figure quoted for the standard Austin Sheerline engine. Not surprisingly, this explains the combustion volume in the new head, 70cc (the as-designed volume of the new alloy head) and the desired 60cc (close to the measured volume in the old head). Following estimation of the cross sectional area of the kidney-shaped combustion chamber and knowing that we need a reduction in volume of 10cc, the amount to skim off the new head can be determined.

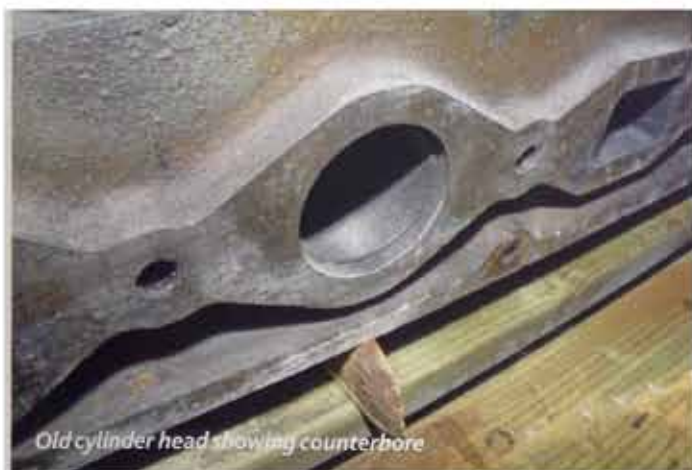
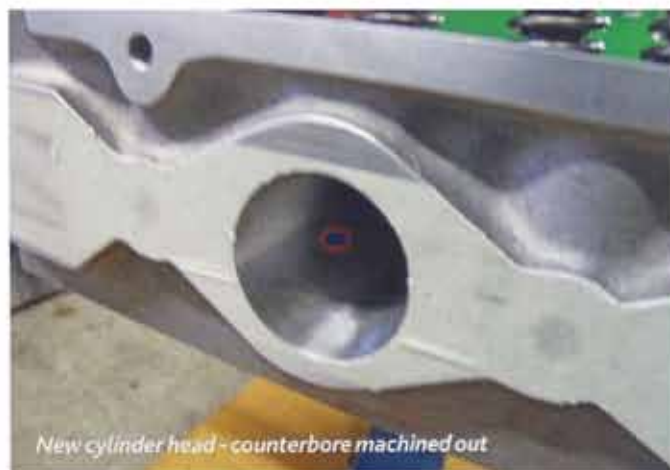
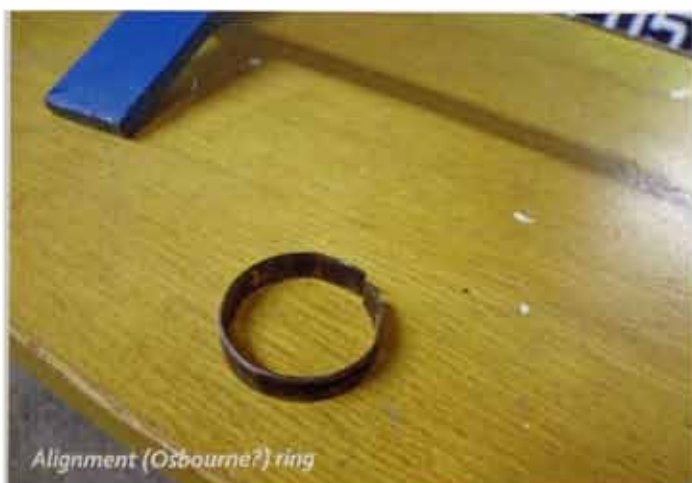
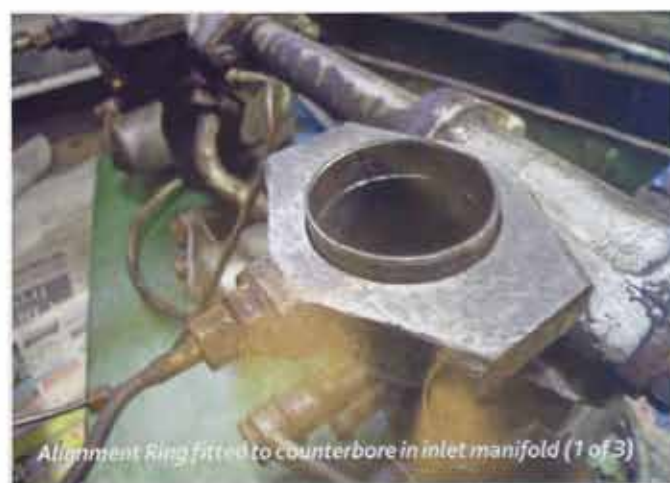
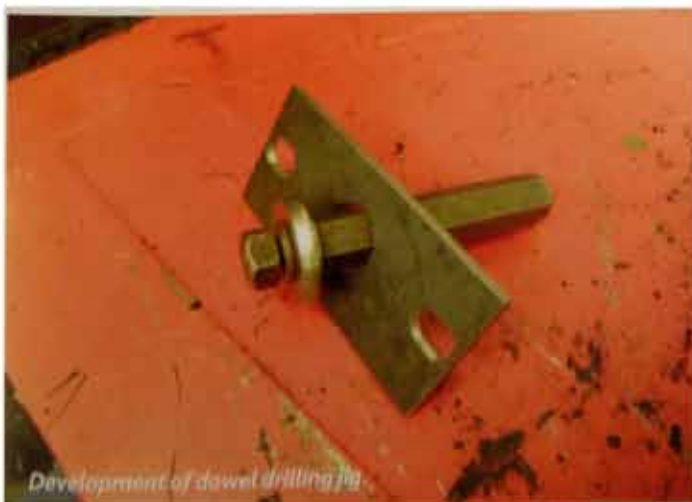
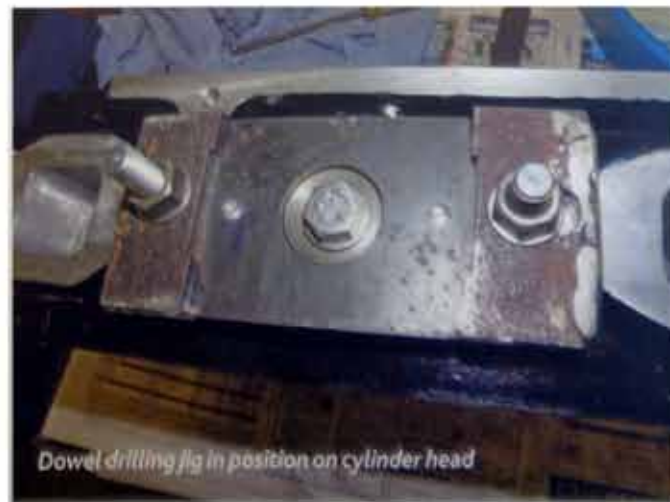
The gas flowing and polishing work on the head had eliminated the counterbore in the inlet ports - thereby removing the original method of aligning the bore of the inlet manifolds to the ports. As a result, DWM suggested the use of roll pin dowels (2 per inlet port) to ensure correct alignment in place of the original split (Osbourne?) rings that

originally pass through the gasket. A drilling jig was manufactured and used to drill the new head and the original inlet manifolds to accept these dowels. The holes drilled were circa 6mm deep and 5mm diameter (slightly larger diameter holes were drilled in to the manifolds with the aim of retaining the dowels in the head during assembly and disassembly). Holes had to be made in the manifold gasket to accommodate the 6 dowels. Note that manufacturing tolerances, particularly in the manifold gasket, meant that the gasket would only fit in one of the 4 possible orientations! The counterbores in the inlet manifolds were ground out to match the smoothed diameters of the ports in the head.
